Roof Asset Management Program

Stayner Tourism Building Roof Report 2024

September 09, 2024

Client: Township of Clearview

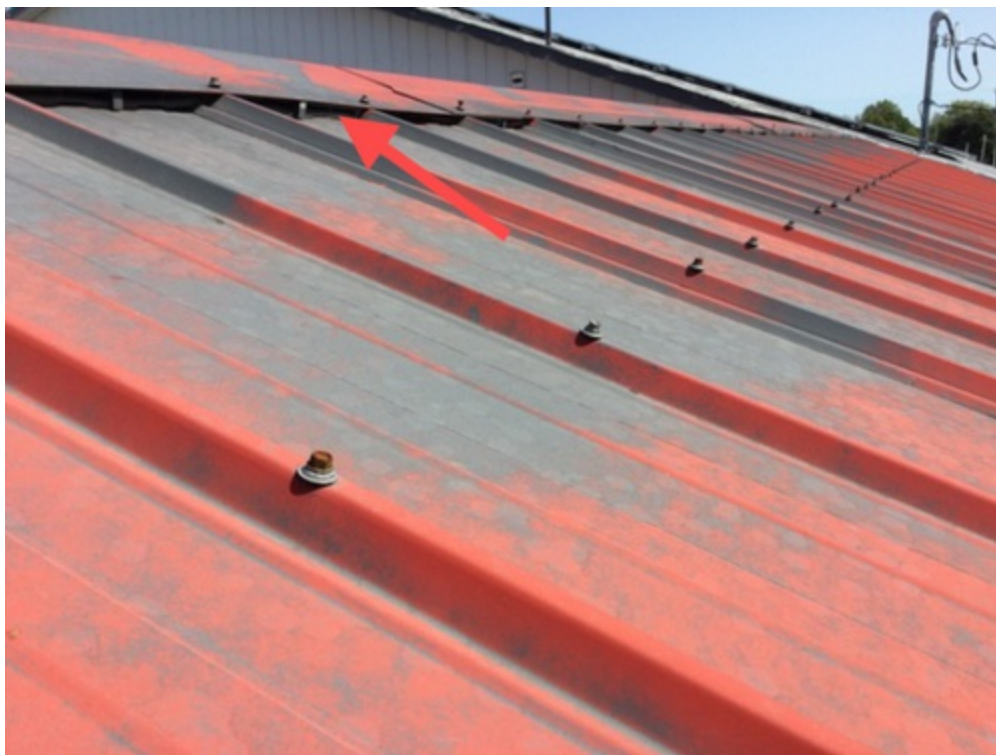
Photo 1

Foam closures are present at the ridge.

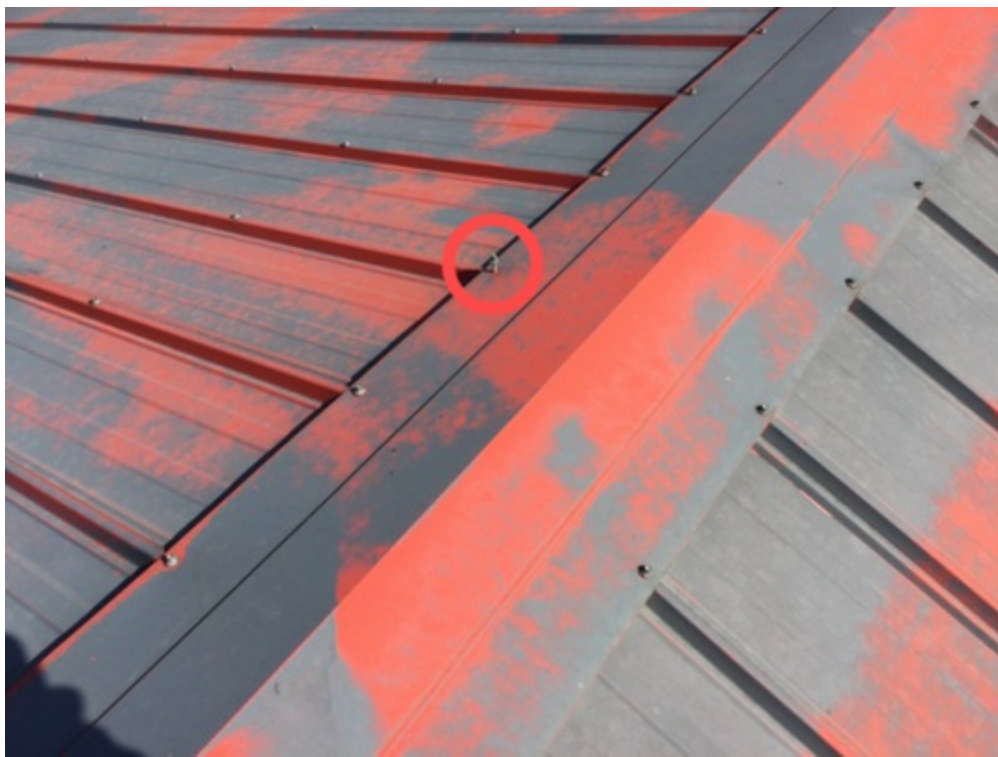
Photo 2

Fastener Back-Out: This is a very common condition on this type of metal roof. When the metal expands and contracts the pressure causes the fasteners to create pressure on the panel increasing the size of the fastener penetrations. This coupled with thermal bridging causes the fasteners to back out of the metal. In this case water can then enter the building and walls causing leaks and in some cases damage to the mortar or concrete existing in the wall.

This is a poor design for the Canadian climate due to the large temperature shifts as a result of seasonal changes. The fasteners must be fastened through to a structural member such as a purlin. When the fastener backs out, water will leak inside, straight onto the purlin or structural member. Over time, this can compromise the structure.

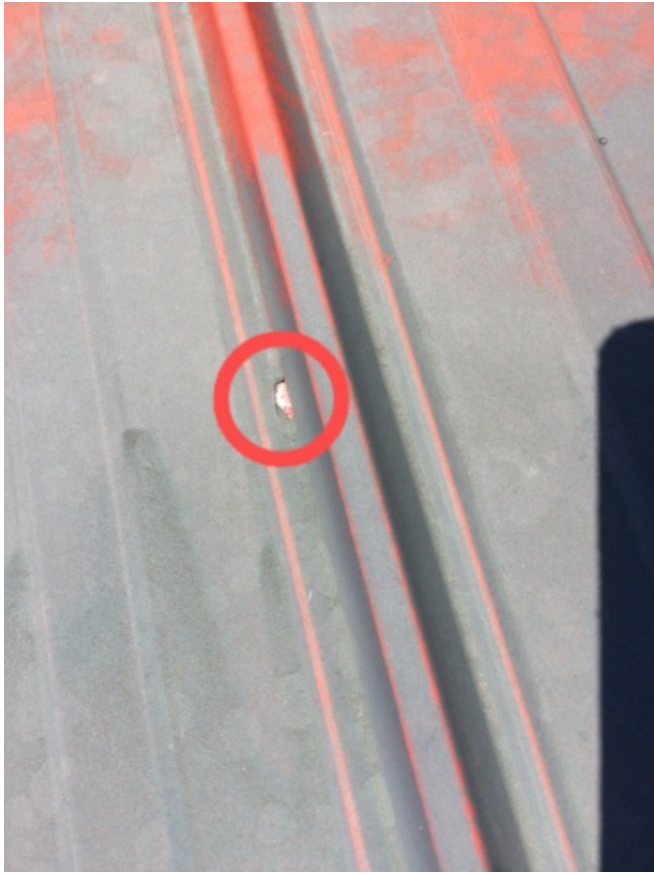
Photo 3

Peeling of the existing coating is very minor.

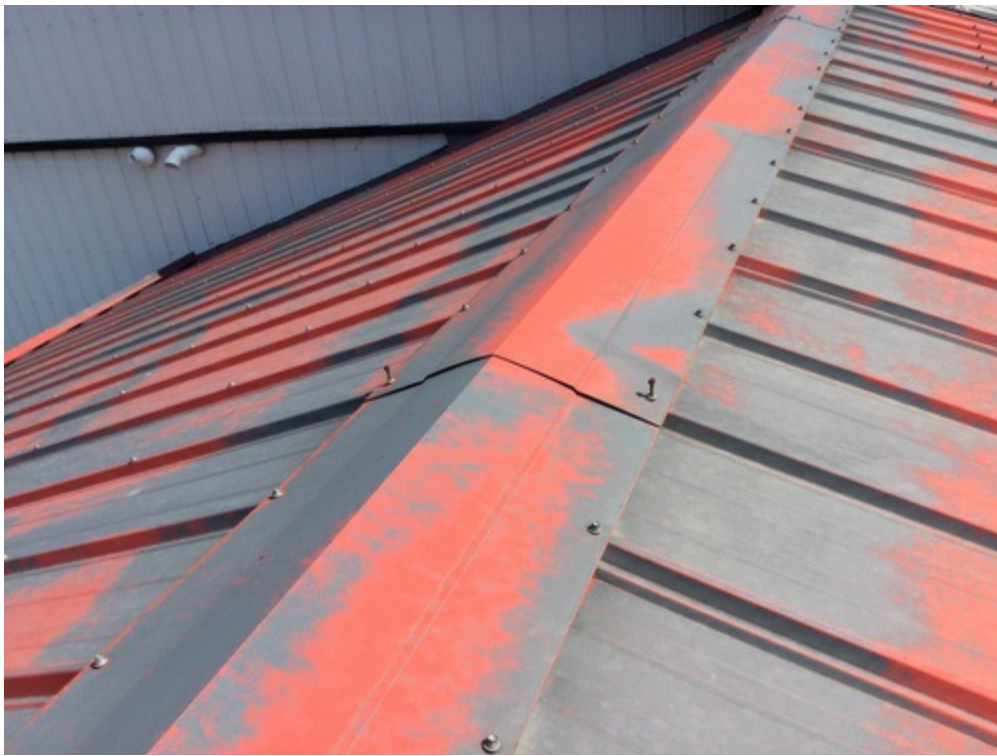
Photo 4

Fasteners backing out at the ridge.

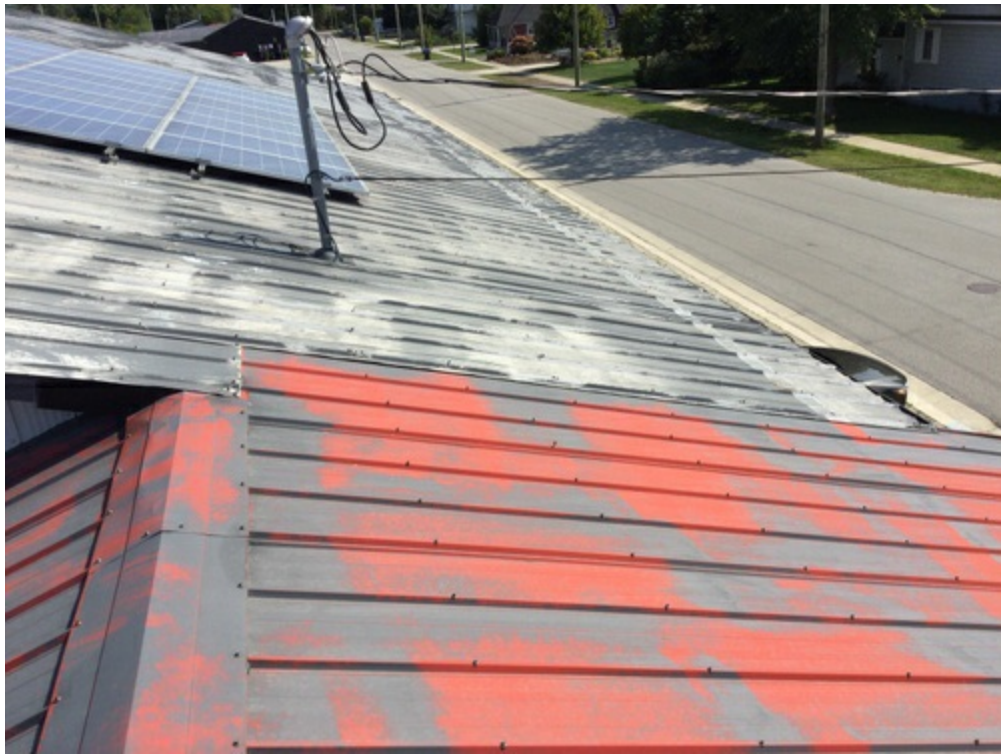
Photo 5

Transition to the remainder of the roof.

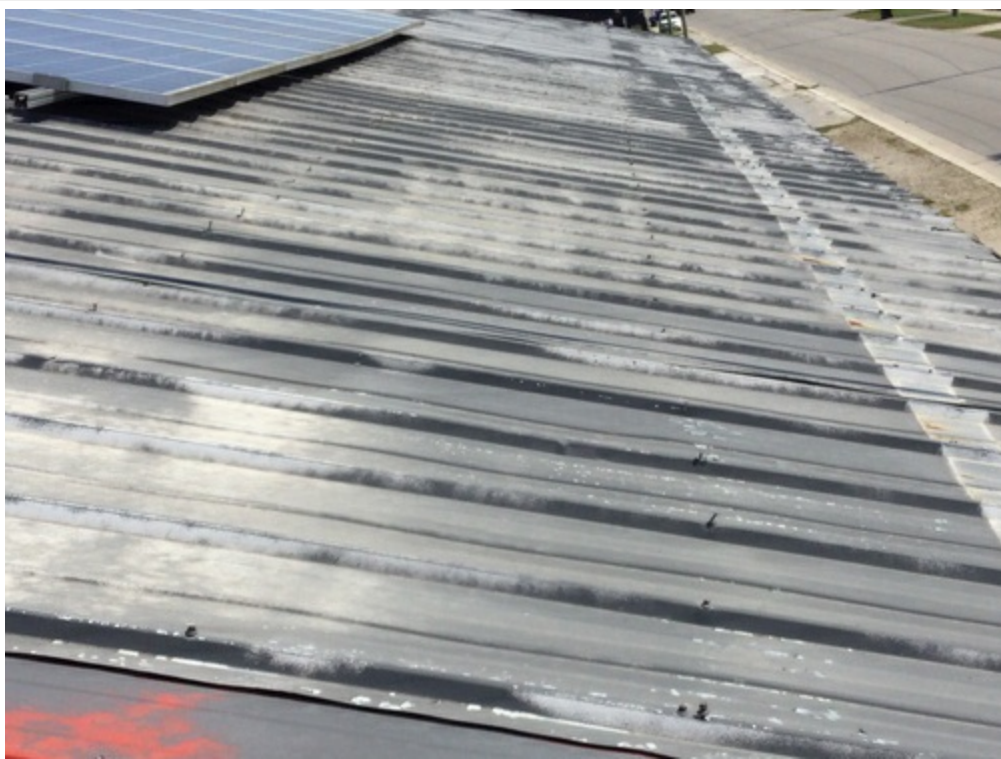
Photo 6

A closer look. Note the fasteners backing out throughout the area.

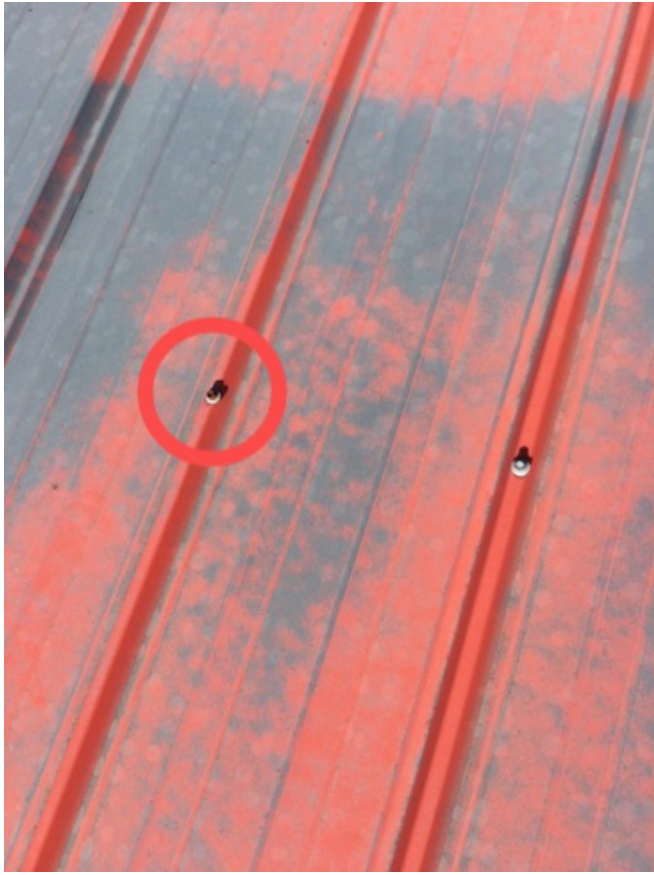
Photo 7

Some fasteners are in a state of corrosion.

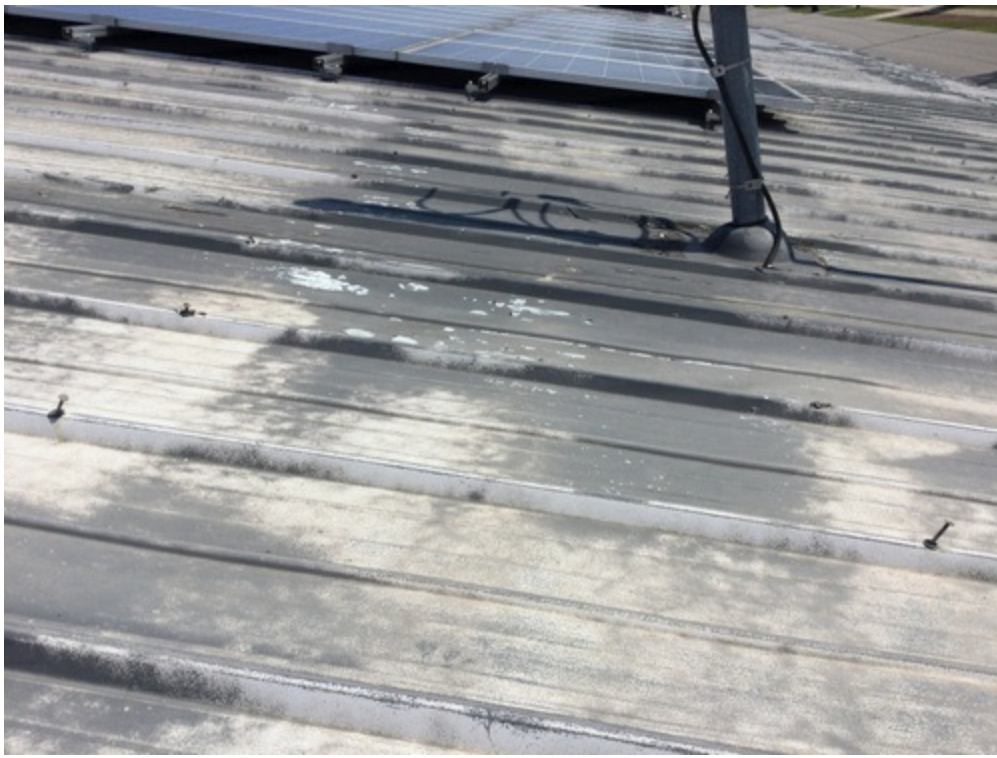
Photo 8

Many of the nails that were used on this section are backing out. Fasteners should be used instead of nails.

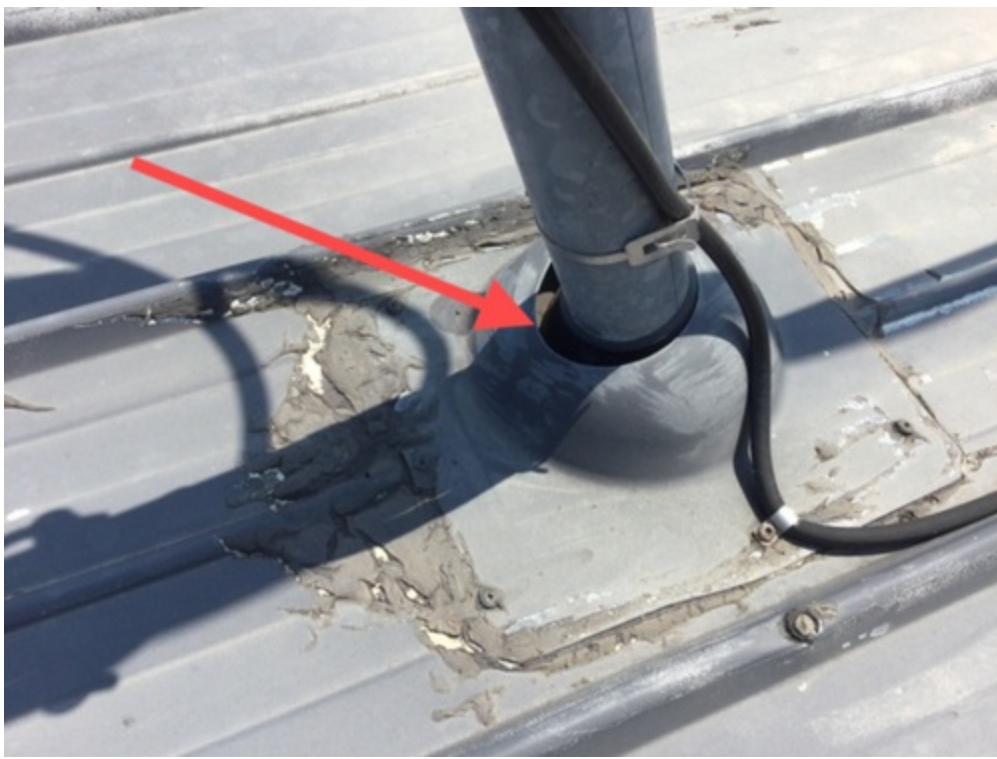
Photo 10

This soil stack is missing a rubber boot.

- Removal and reinstallation of the solar panels not included.
- Power wash and clean entire roof surface.
- Replace any missing fasteners and tighten backed out fasteners where needed.
- Apply sealant along fasteners where required.
- Apply one coating of Metal Roof Coating along entire roof at a rate of 3 gallons/100 linear feet and allow to cure.
- Embed polyester fabric with an 80% bleed out rate.
- Apply one coating of Metal Roof Coating along entire roof at a rate of 2 gallons/100 linear feet and allow to cure.
- Apply one coat of non-fibered reflective aluminum coating along entire roof.
- Install rubber boot for soil stack.
- Install storm collar at pipe/boot penetration.

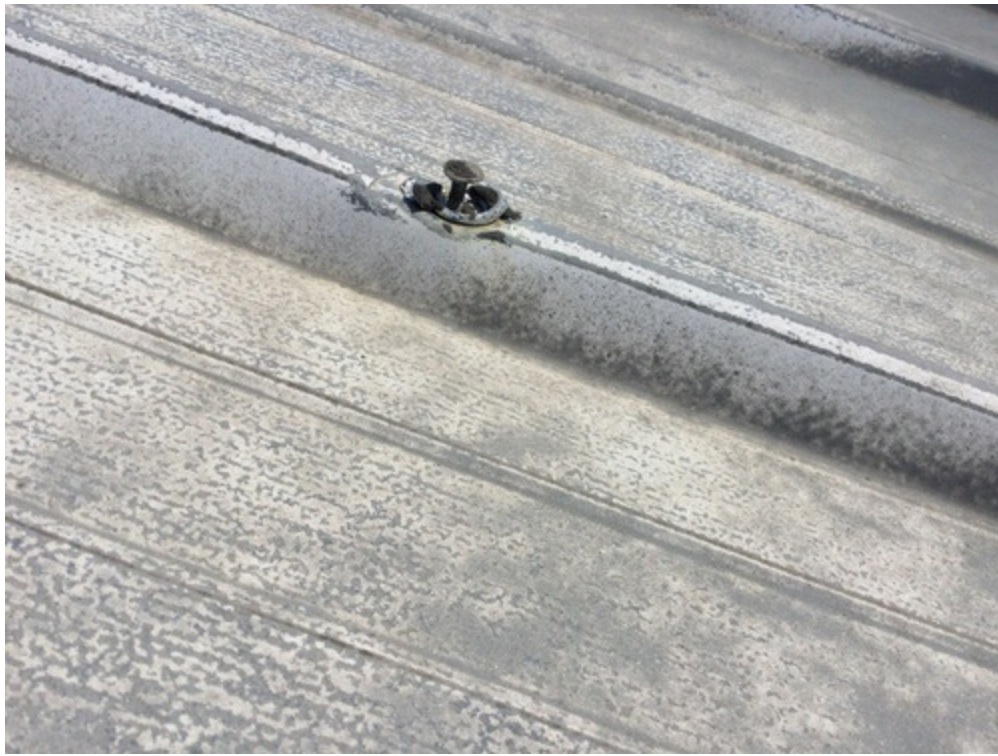
Photo 11

Close-up of a backing out nail.

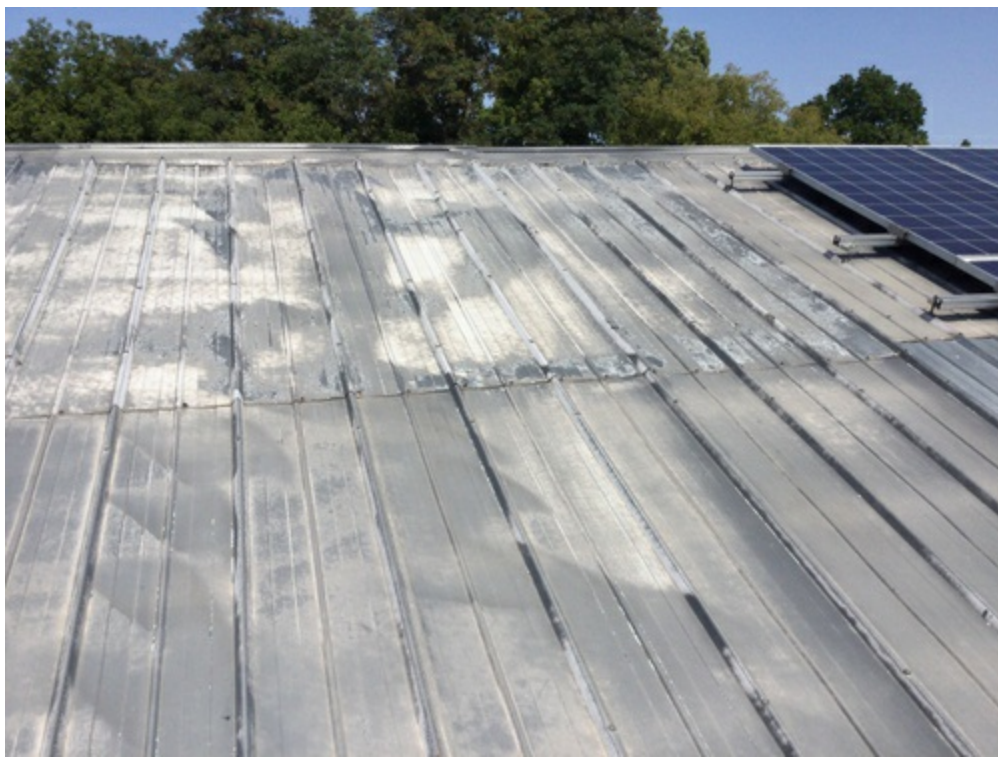
Photo 12

A view of the gray metal panels.

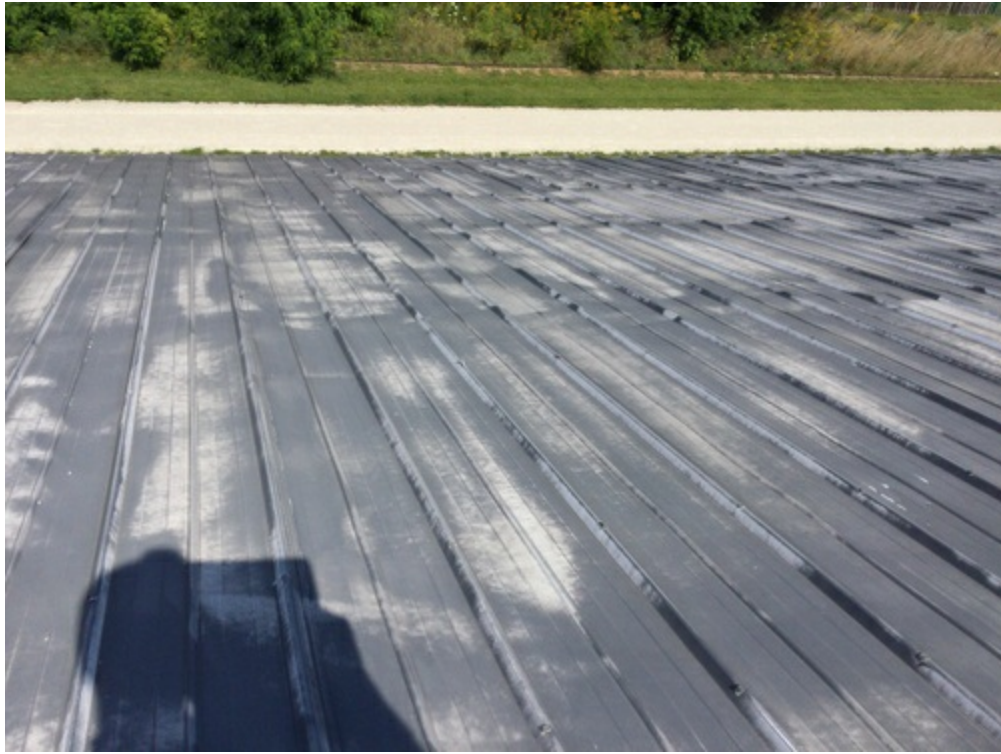
Photo 13

Same as previous.

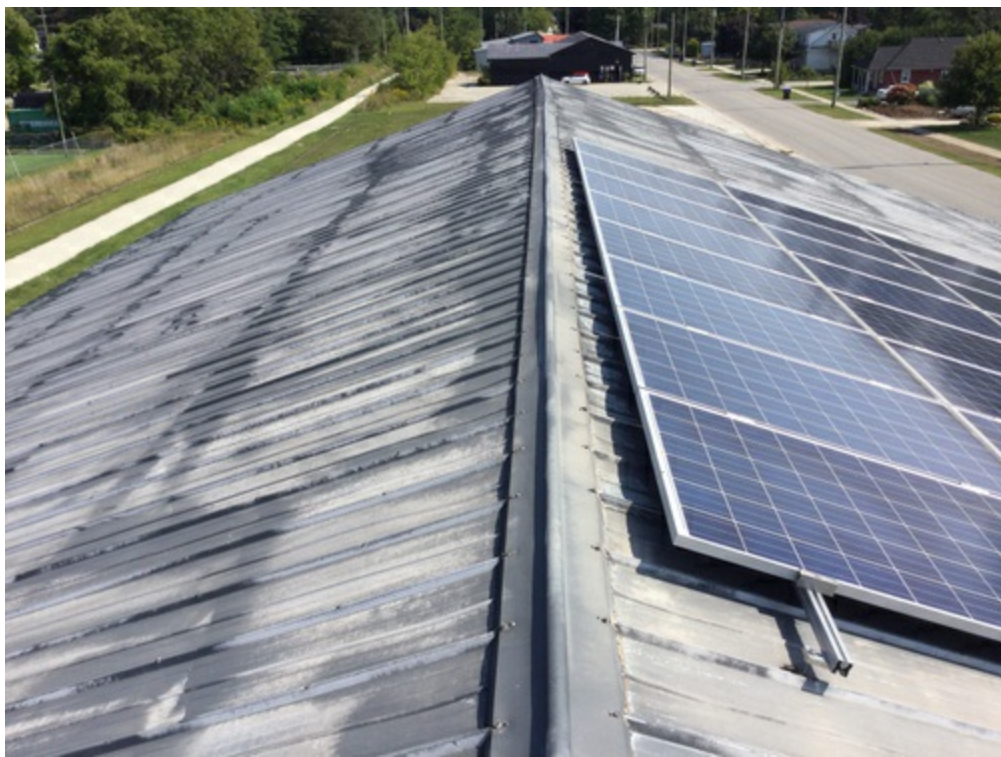
Photo 14

Overview of this section of the roof.

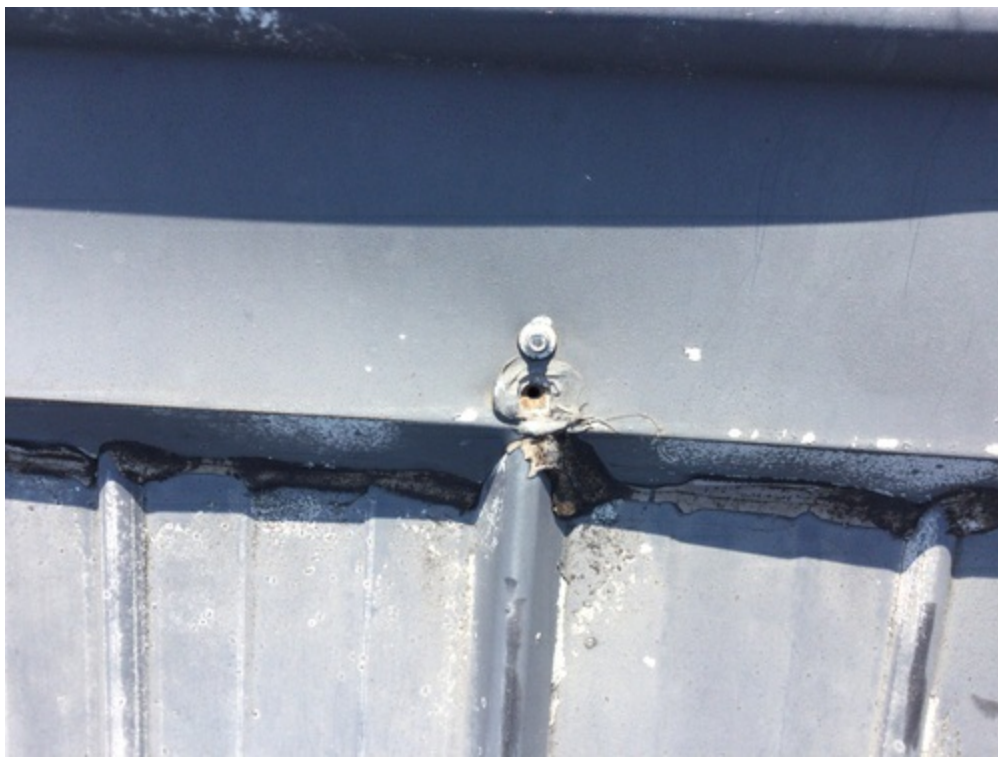
Photo 15

New fastener added next to the hole where an old one backed out.

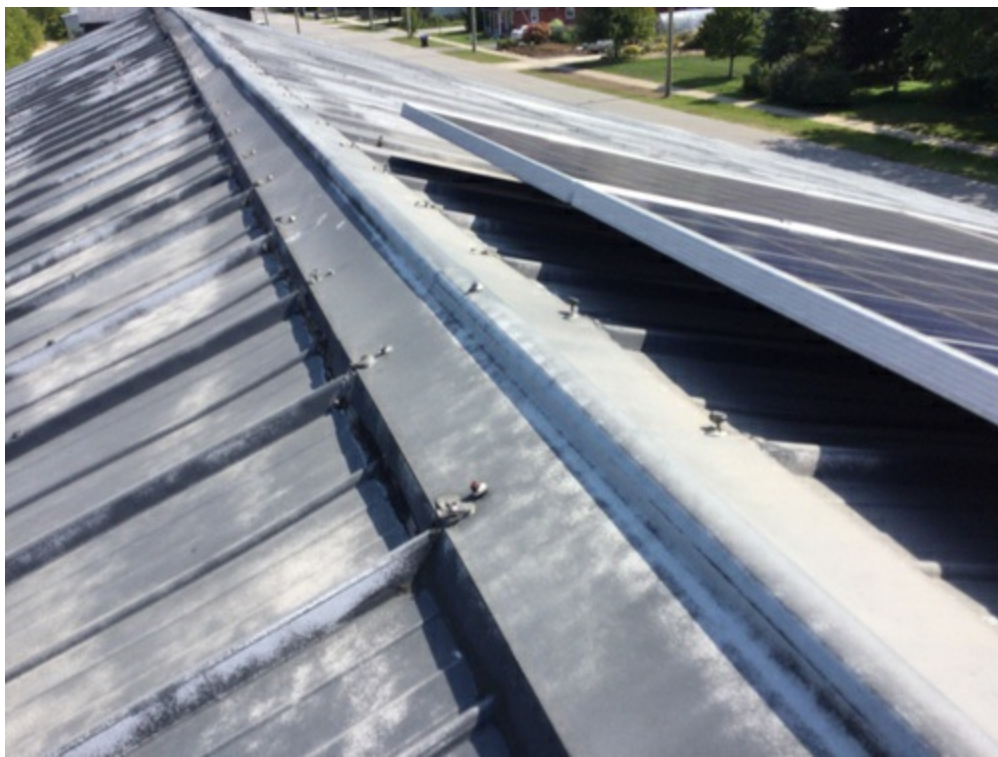
Photo 16

Fastener back-out at the ridge.

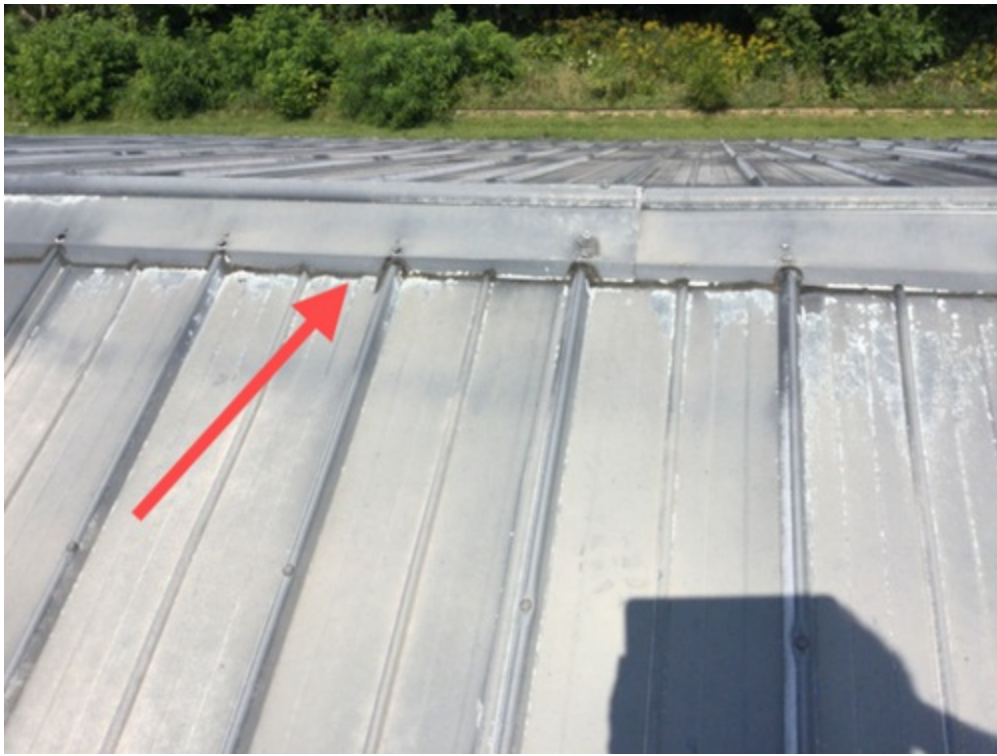
Photo 18

Gaps present at the ridge cap.

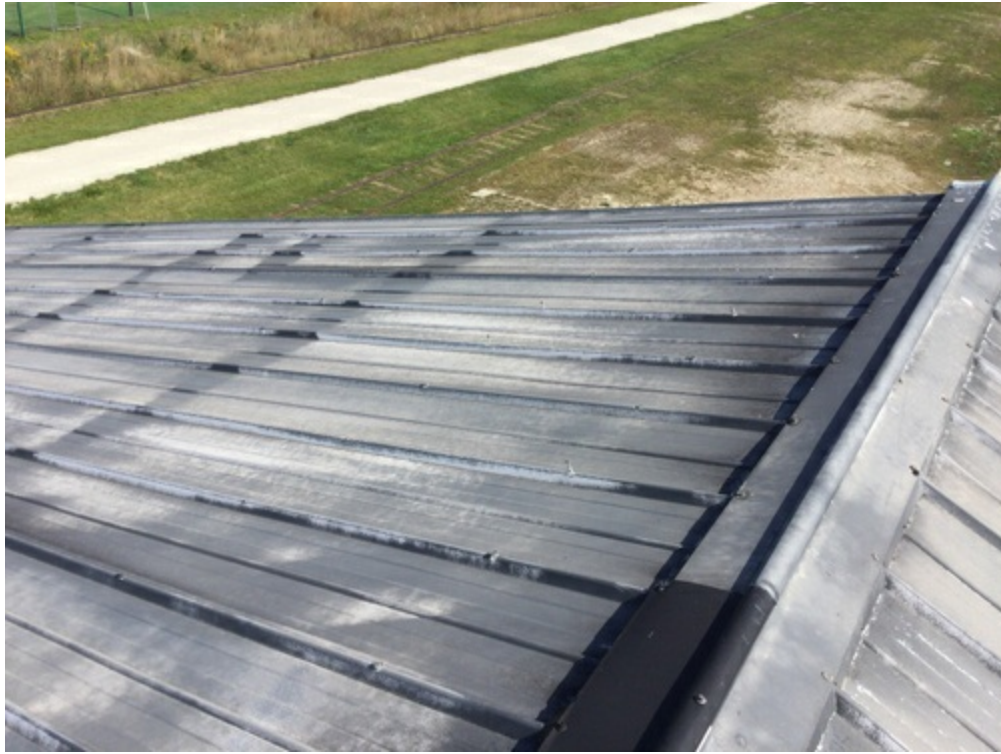
Photo 19

Widespread fastener back-out here.

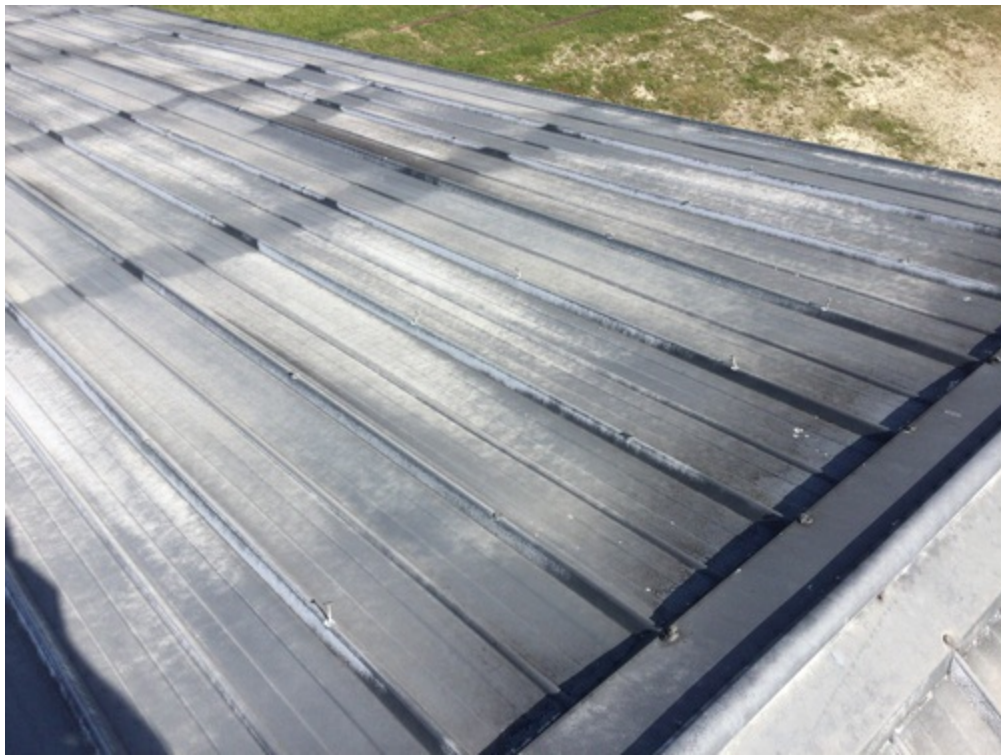
Photo 20

A closer look. Most of these improperly installed nails are backing out.

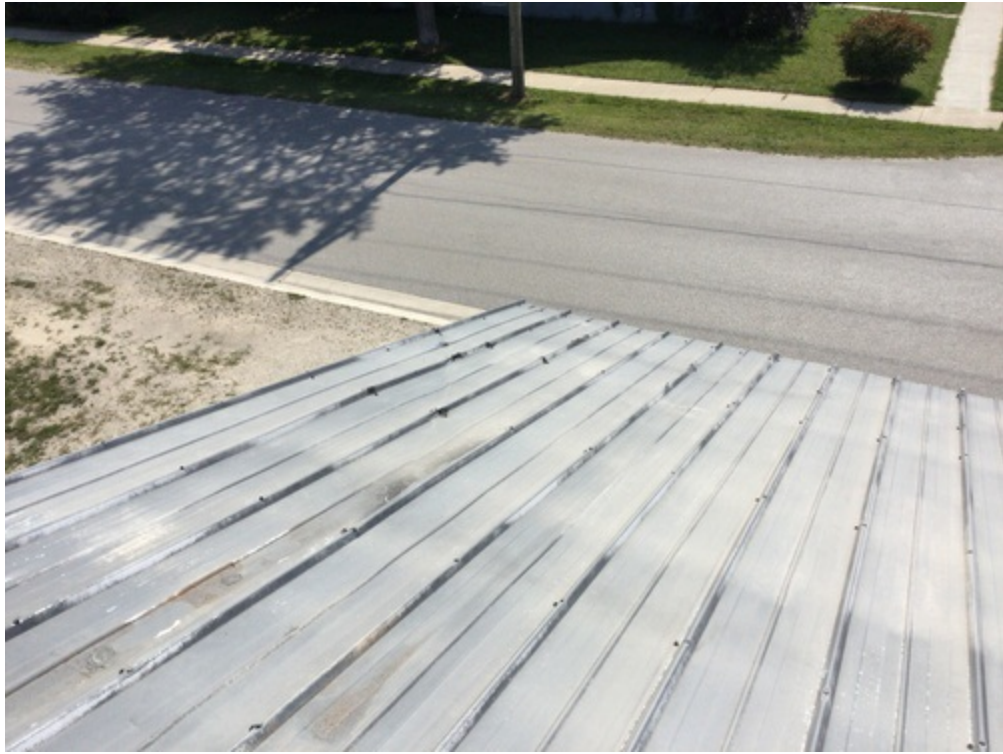
Photo 21

Old backed out fasteners at the bottom corner here have been repaired in the past by others.

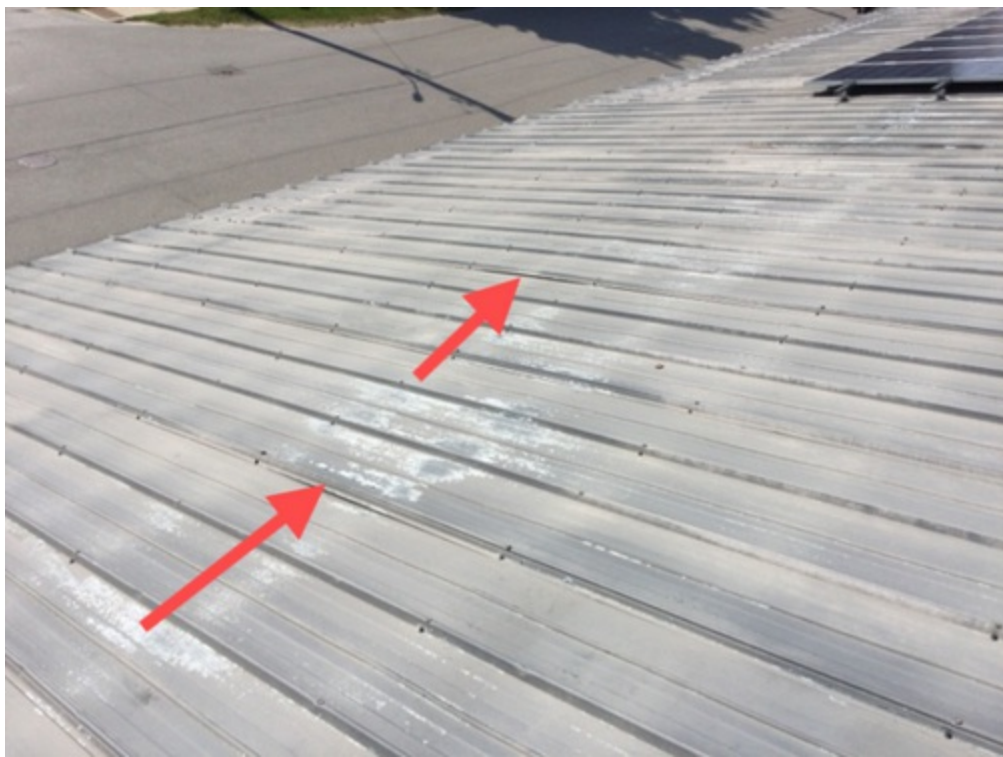
Photo 22

Gaps in seams.

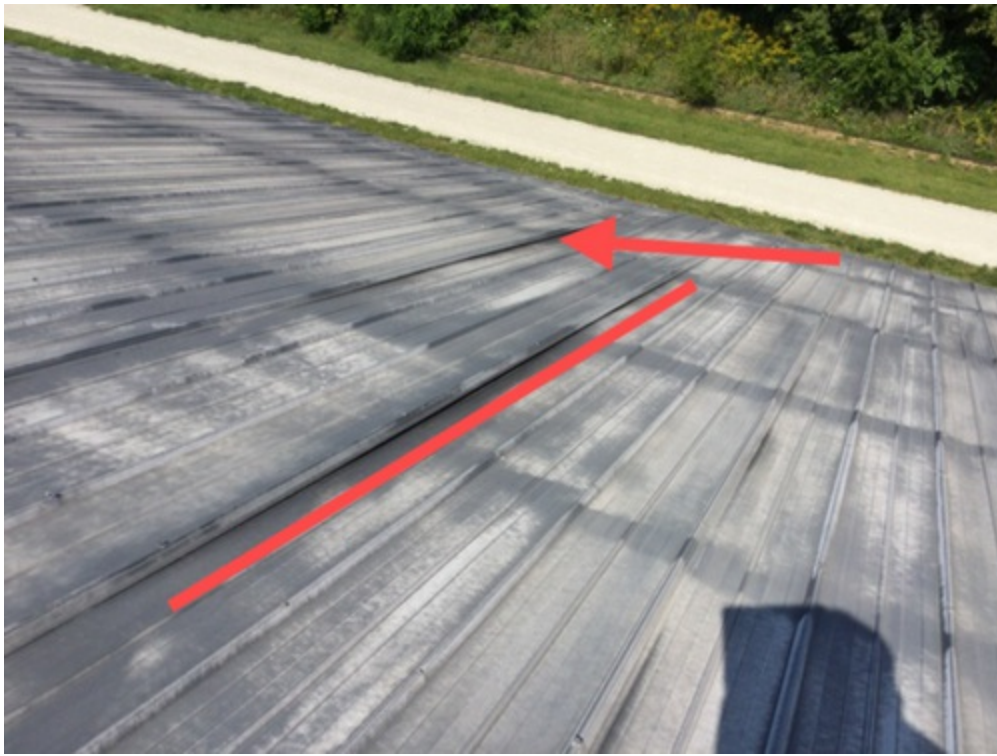
Photo 24

Backed out nails.

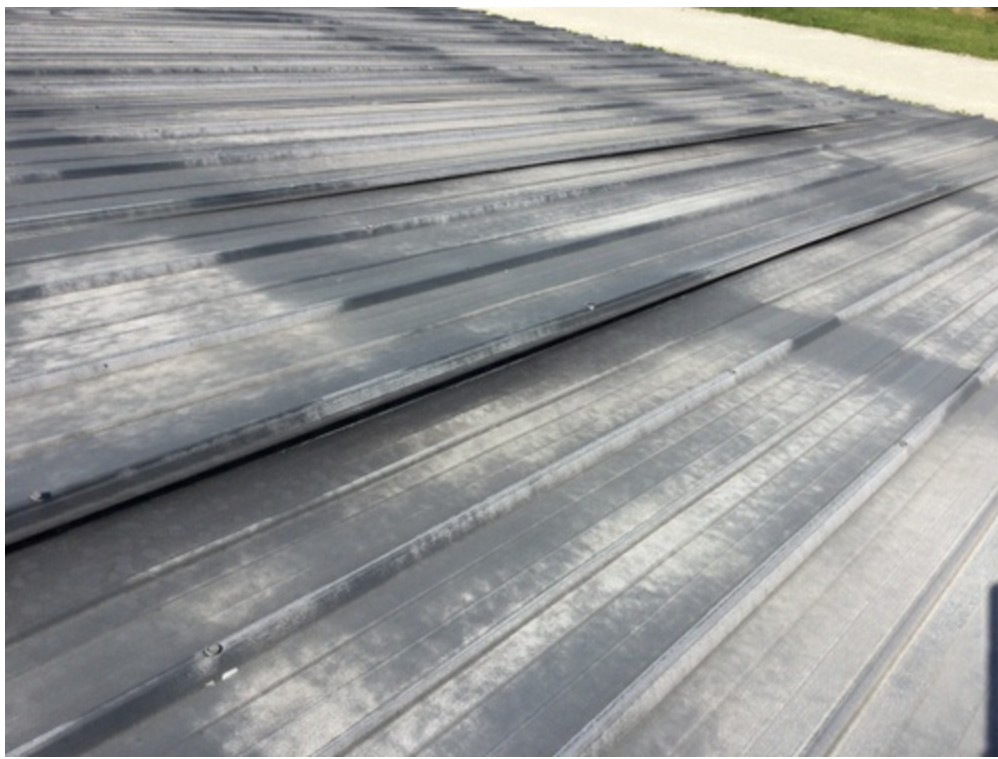
Photo 25

More gaps.

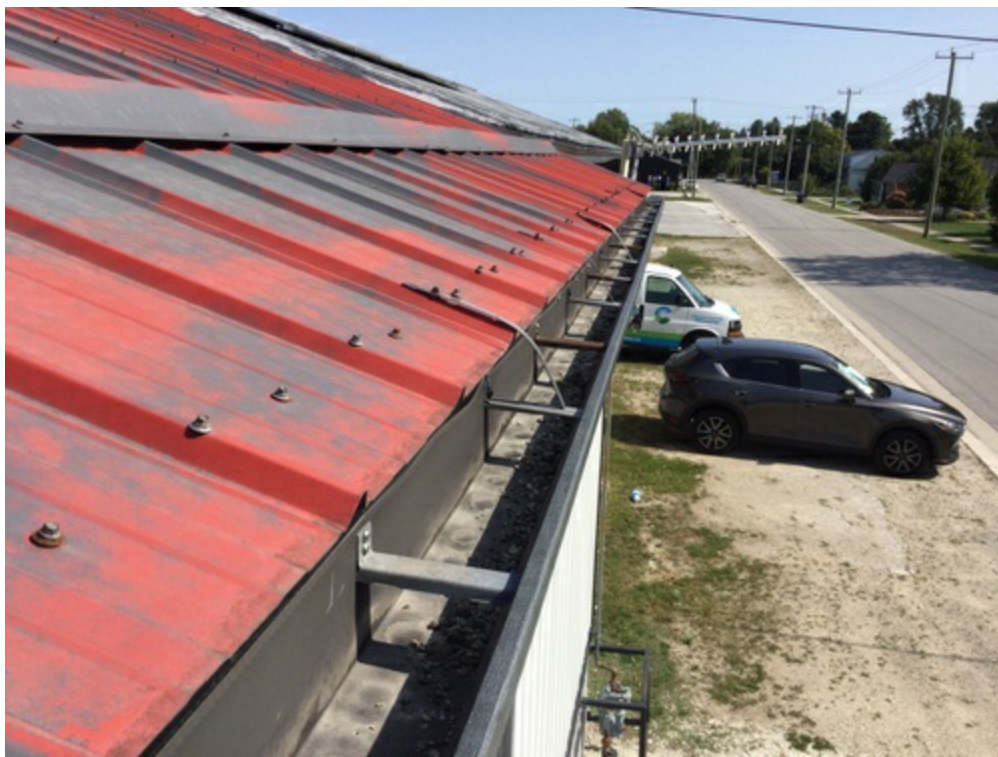
Photo 26

Gutters are clear.
